Note for file

Acceptance Check - Post NATA Calibration of ATI 100Xs ALICAT Flow Meter

VIPAC NATA Calibration Report 47593396-0 dated 03 may 2021 [D21-2602345]

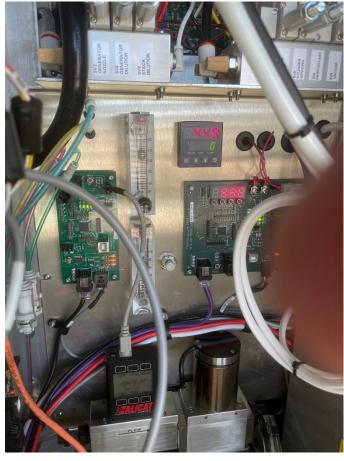
The flow meter was photographed prior to extraction so that it could be re-connected upon return. Before shipment it wrapped in plastic to safeguard against contamination and wrapped in bubble-wrap before placing in a box with sufficient cushioning to prevent damage by couriers during transport.
